# Facilities Assessment Report - FINAL

Dixieanne Campus \ Sacramento, California \ March 2017

# **DIXIEANNE CAMPUS FACILITY ASSESSMENT**

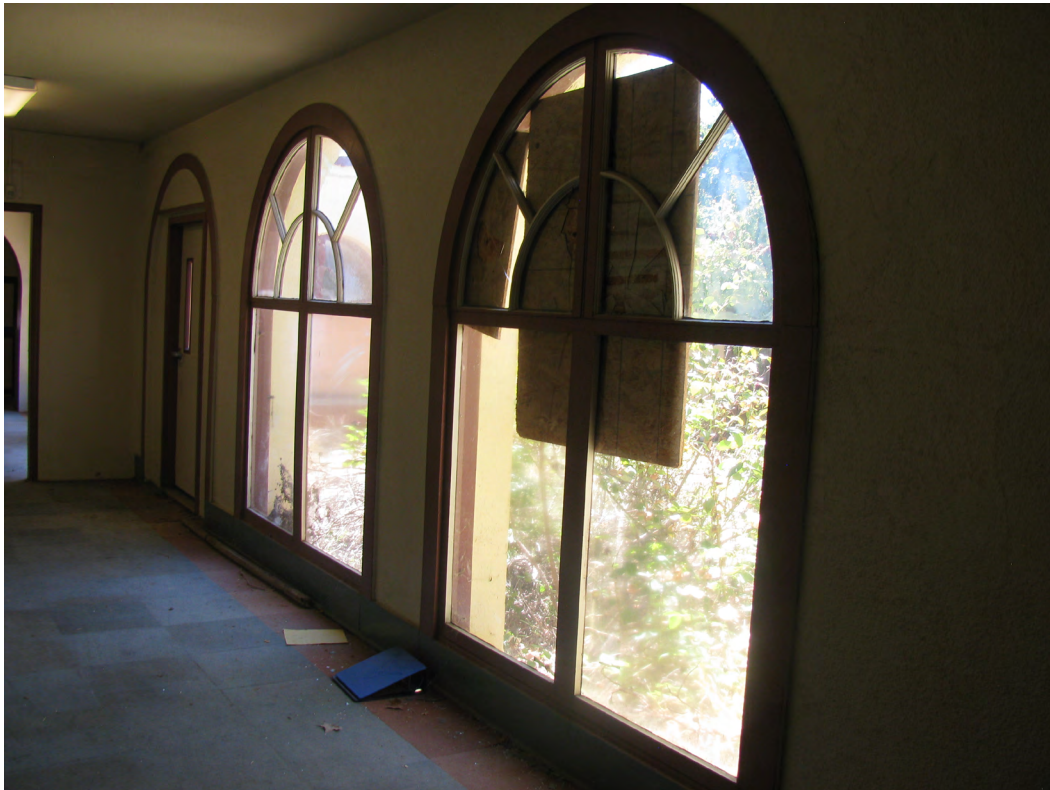
1

Damaged single pane decorative windows along hallways.

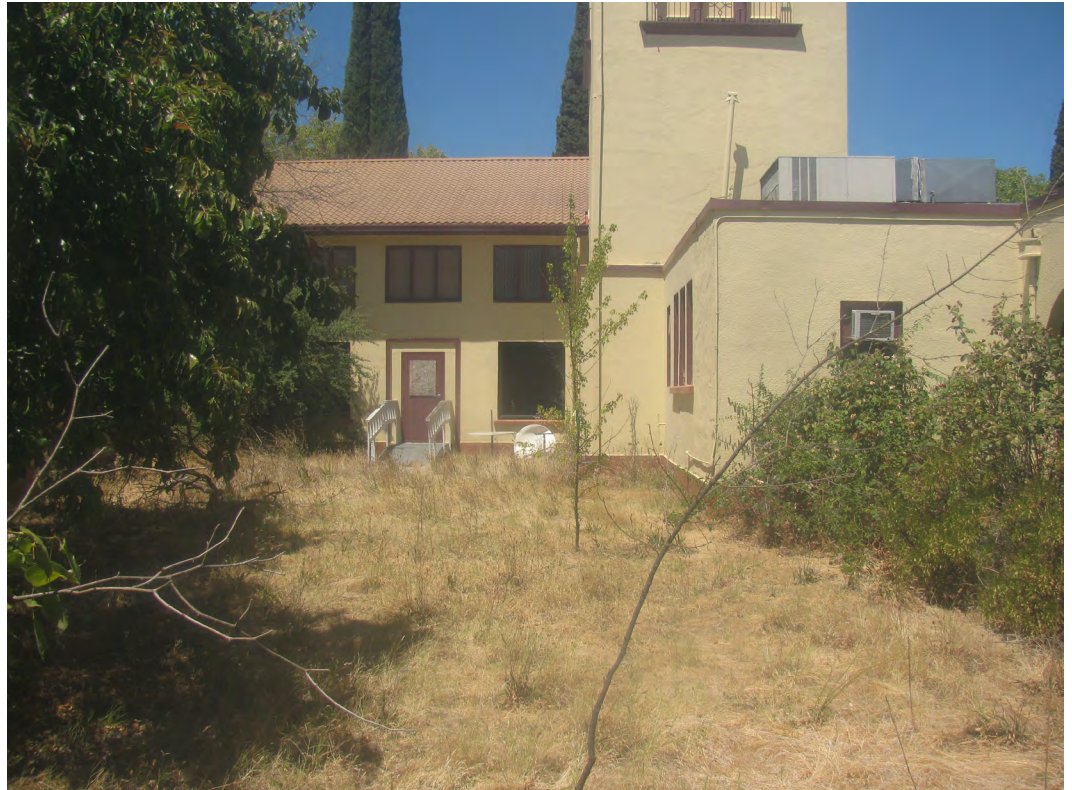
**2**

Main central courtyard with overgrown and landscape and broken irrigation.

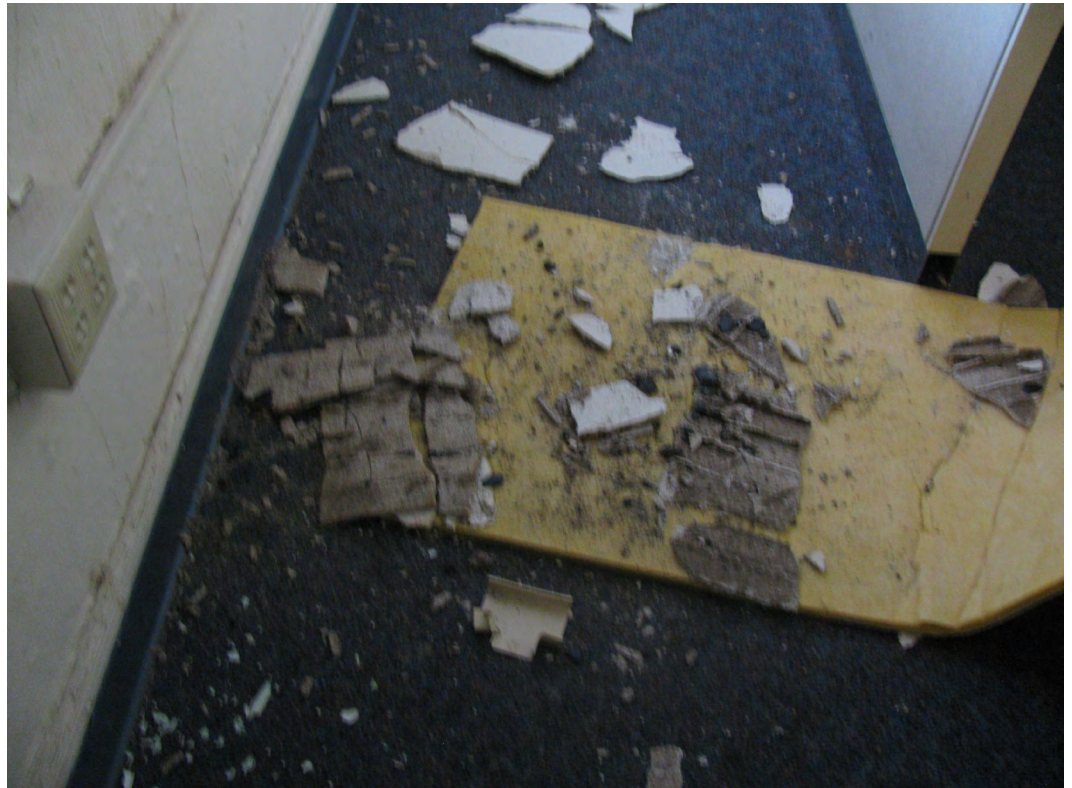
**3**

Water damages ceiling debris and water soaked floors at offices and halls.

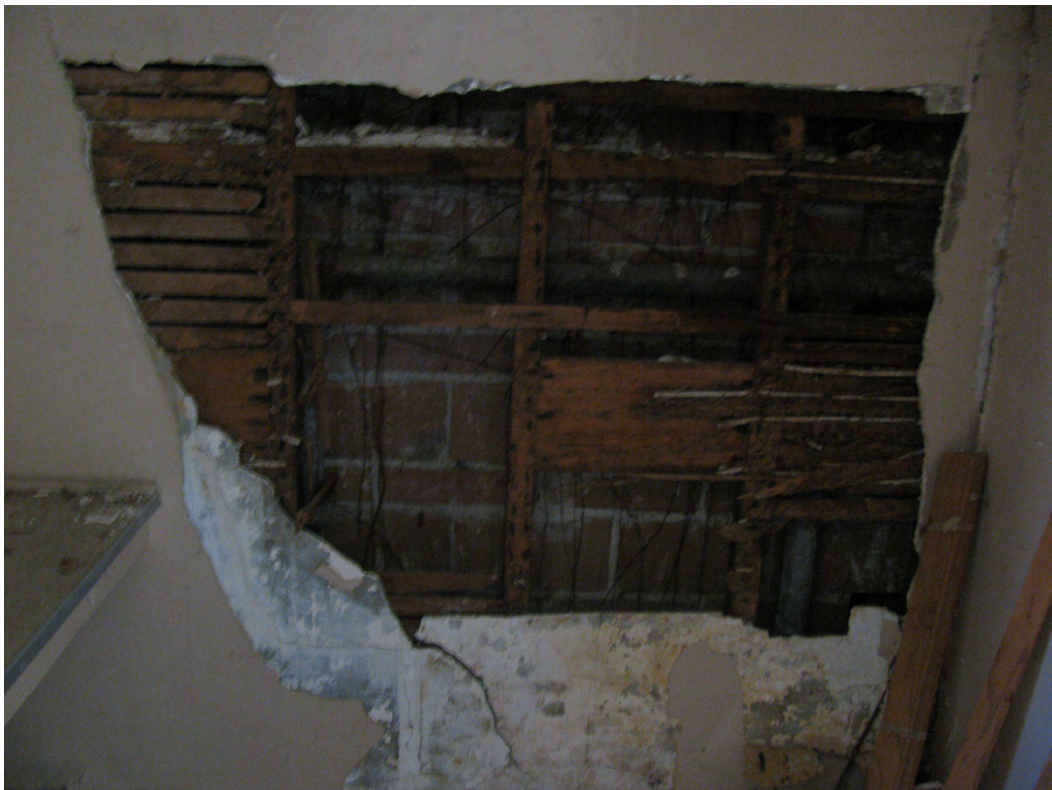
4

Water damaged walls studs, dry rot and termites at various walls.

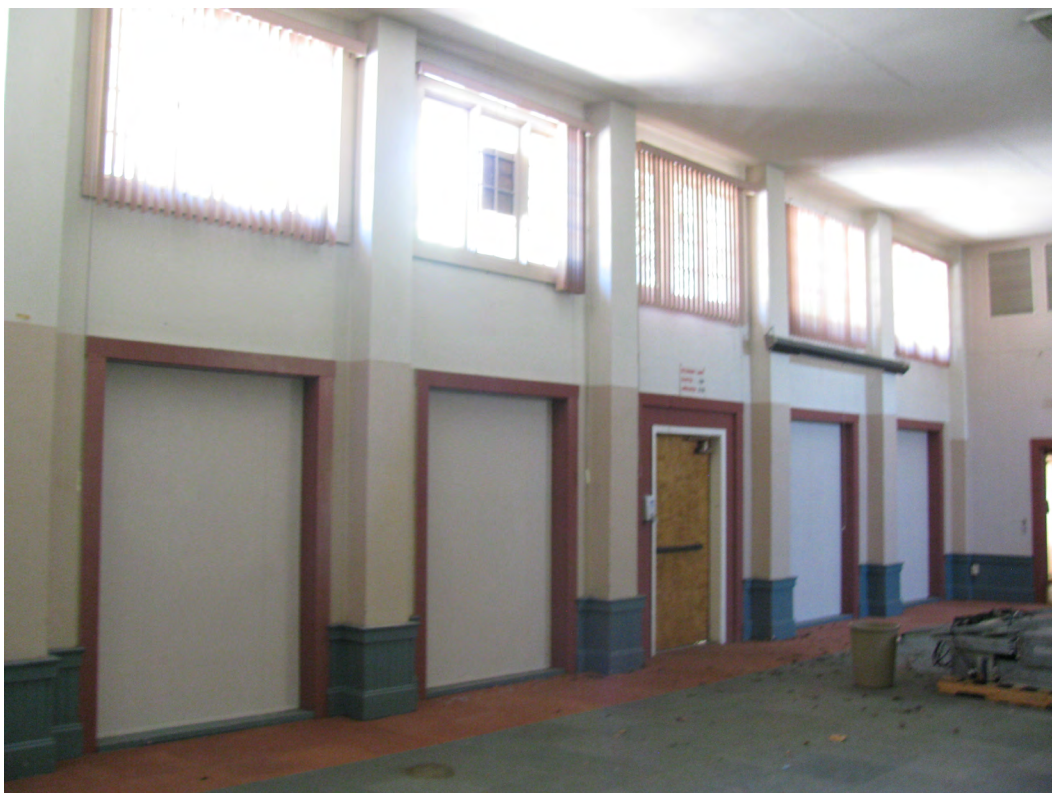
5

Damaged upper windows and boarded up French doors/windows at Auditorium.

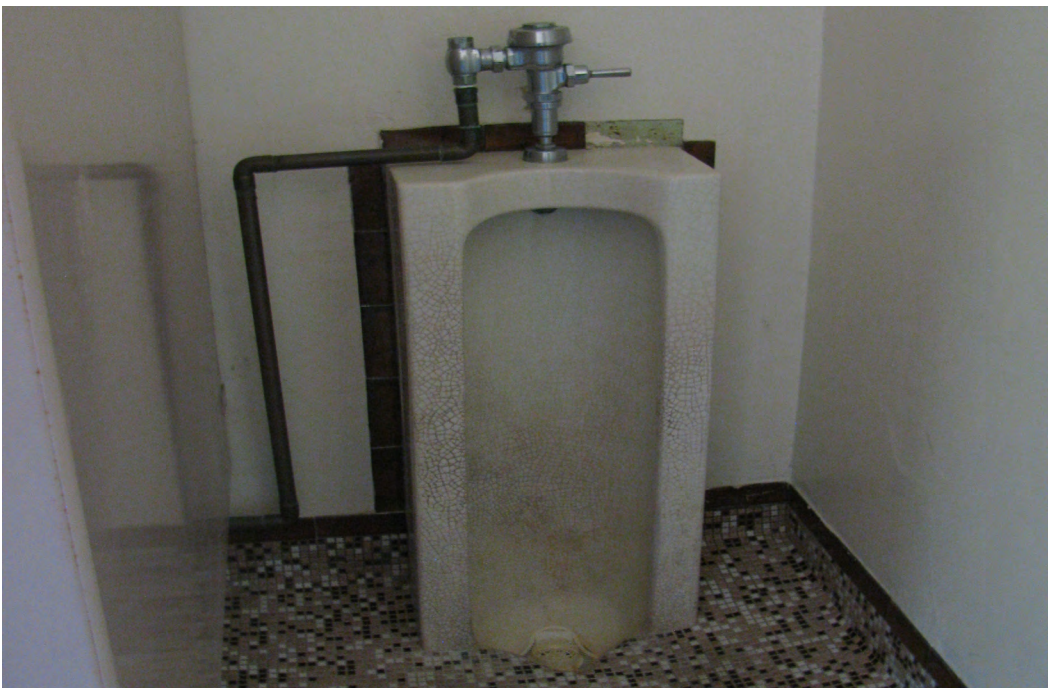
1

Urinals at men's restrooms. All non ADA compliant.

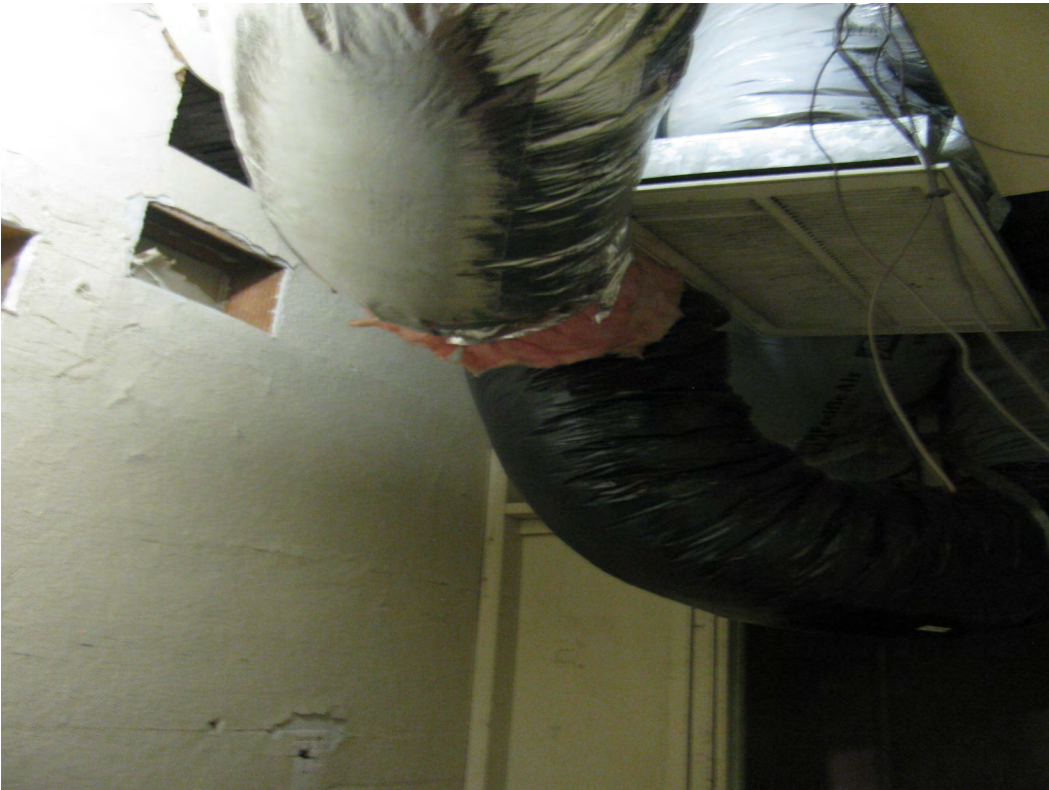
2

Exposed ductwork, supply and return registers and conduit at offices.

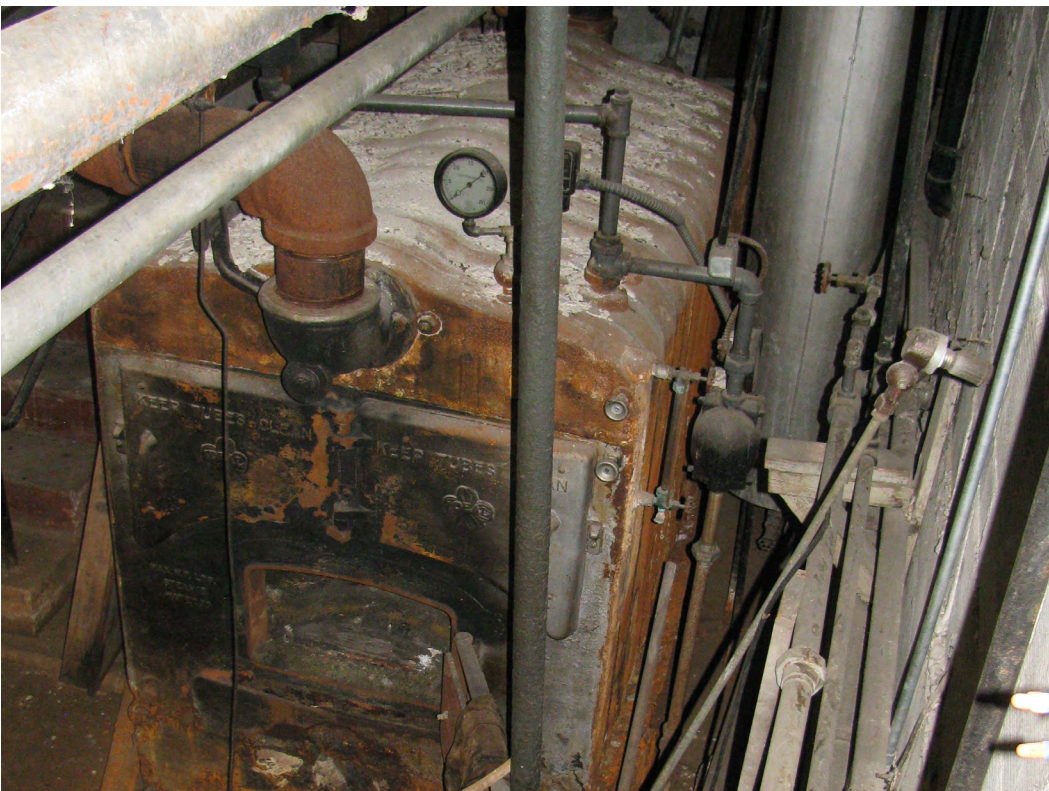
3

Existing boiler room for heating system.

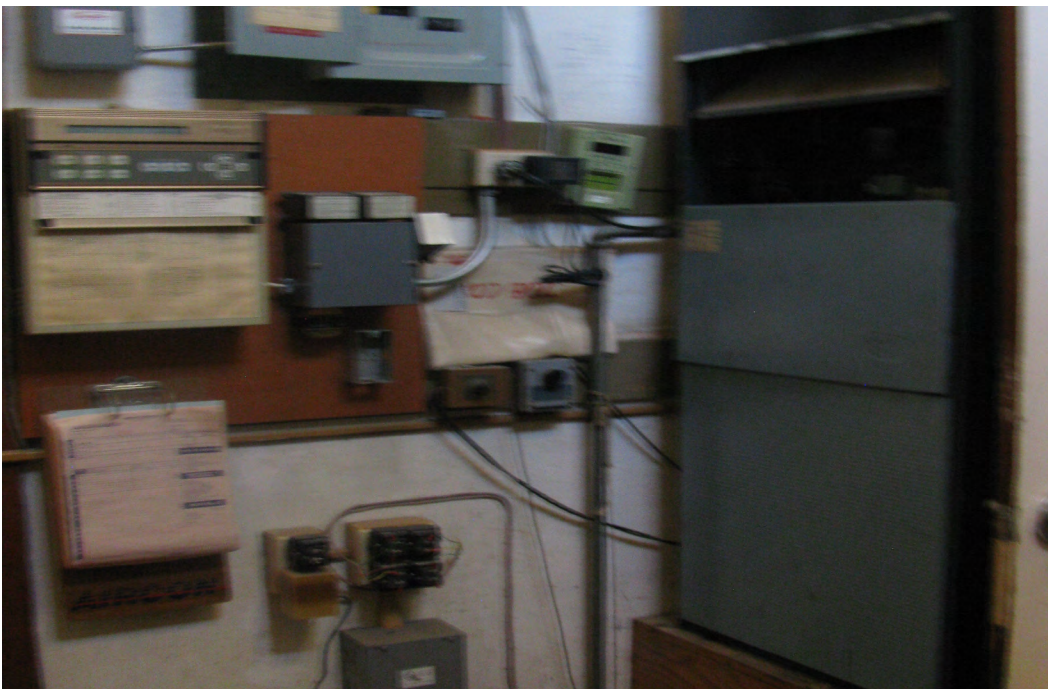
1

Existing crowded electrical rooms and closets.

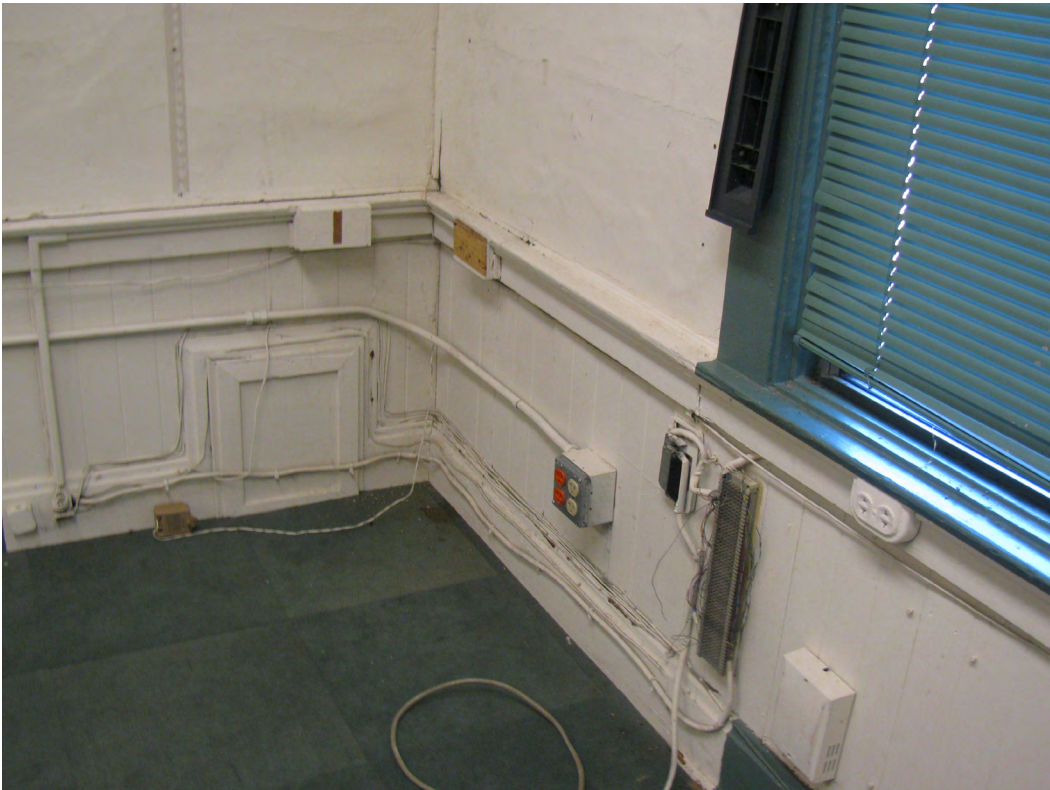
2

Surface mounted electrical boxes, conduit and wire mold at offices.

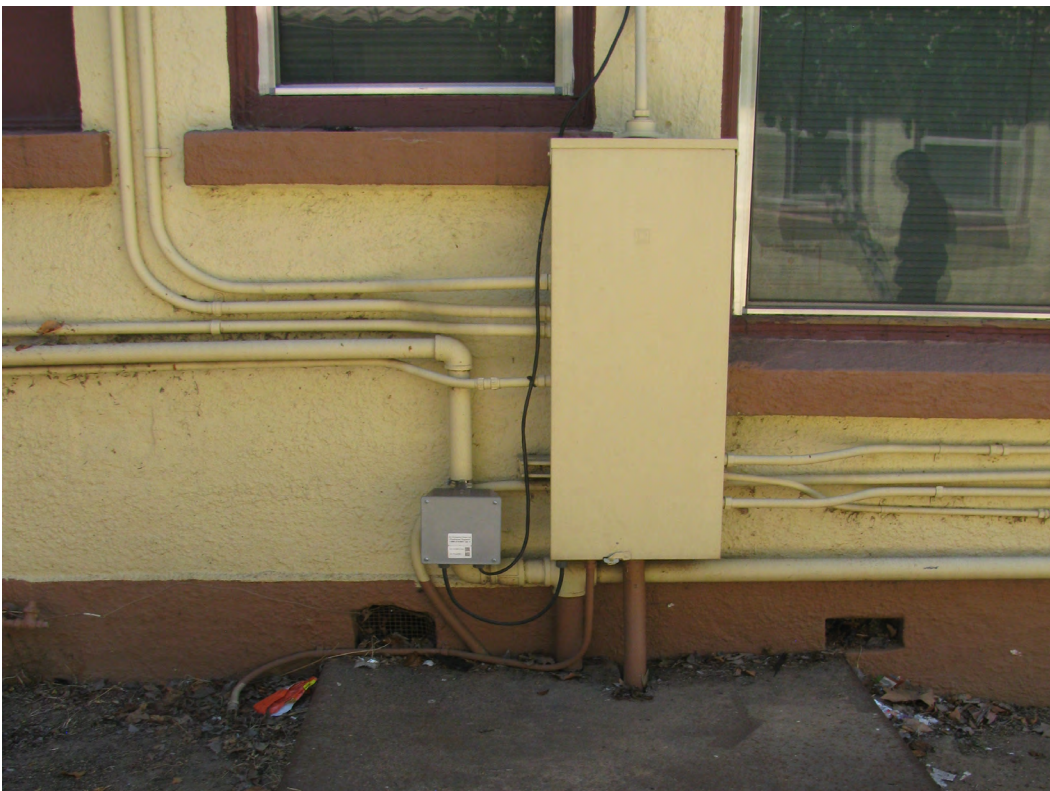
3

Surface mounted electrical boxes and conduit at courtyards.

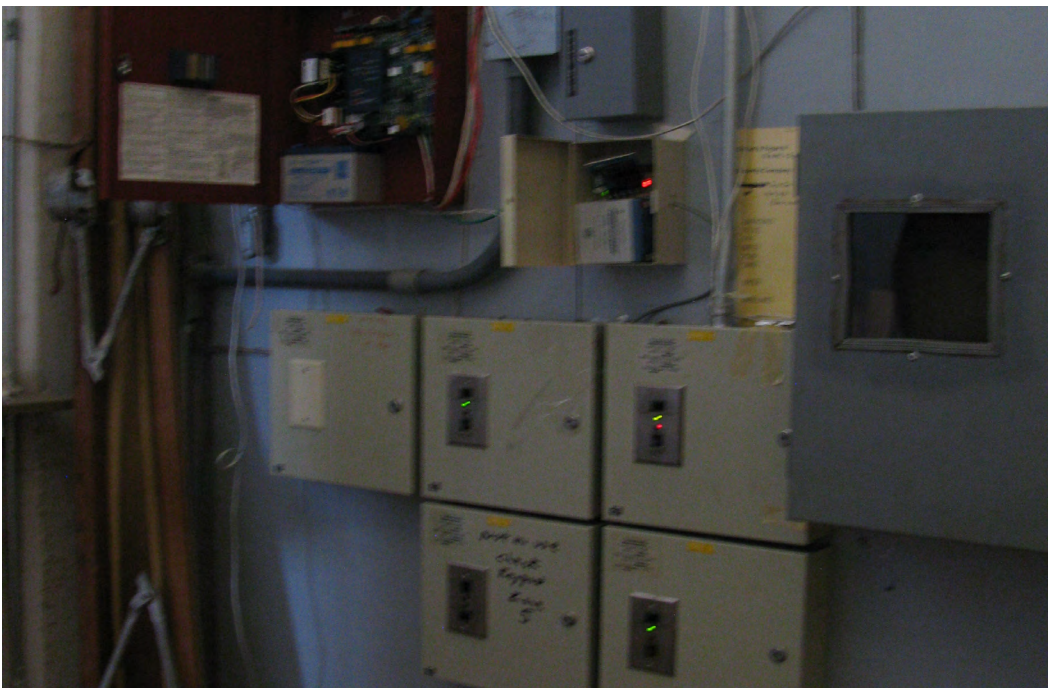
1

Obsolete fire alarm systems and low voltage equipment.

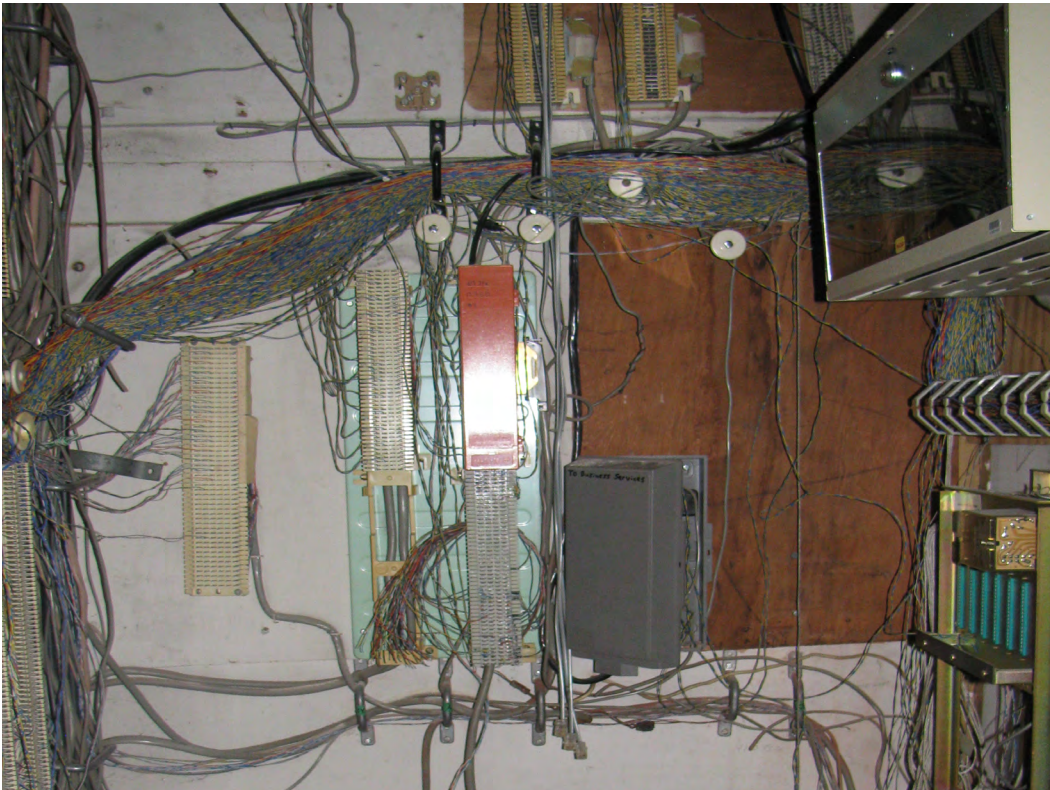
2

Crowded and obsolete phone and low voltage equipment closets.

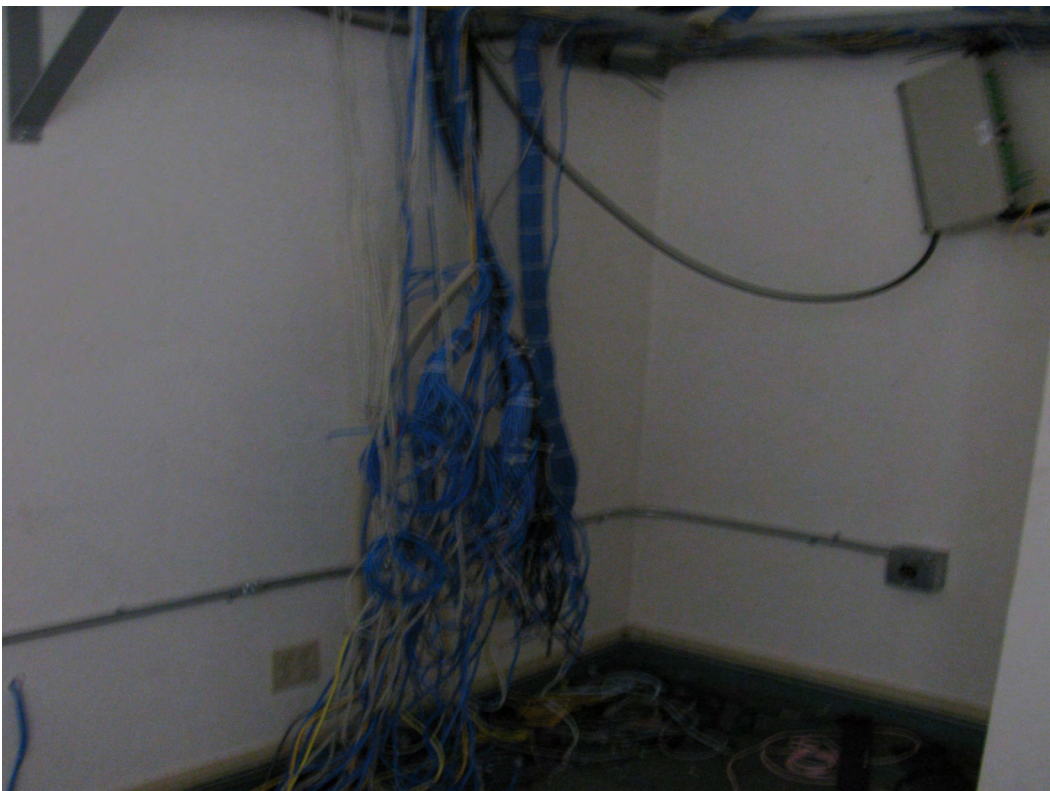
3

Damaged low voltage and data rooms with cable tray.

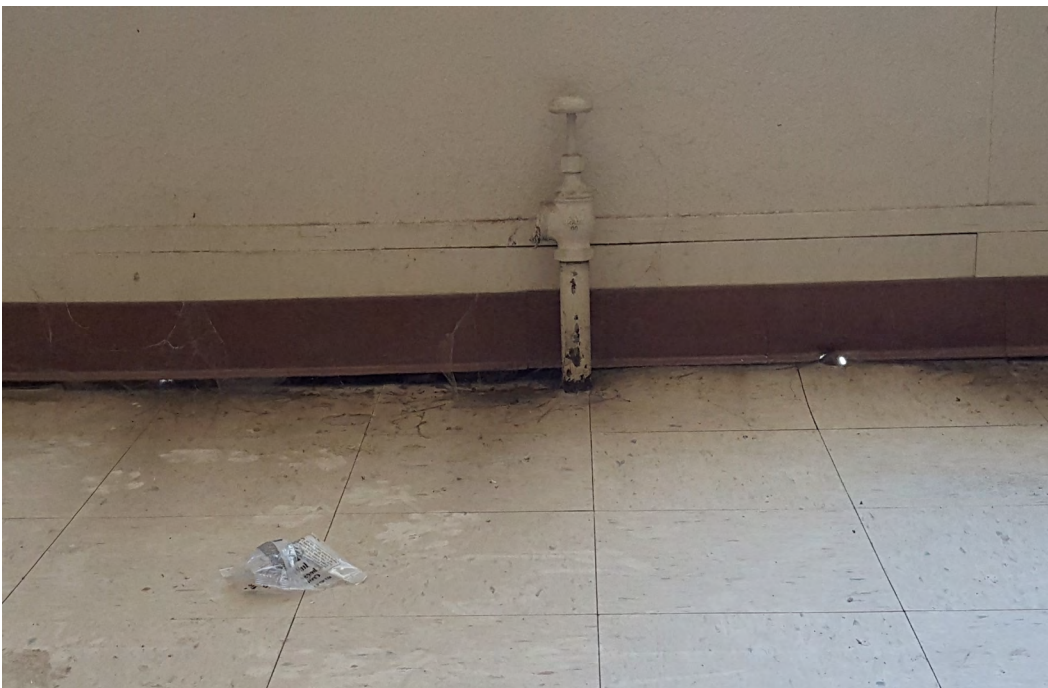
1

Sub-floor at classroom space sagging. Separating from sill plate.

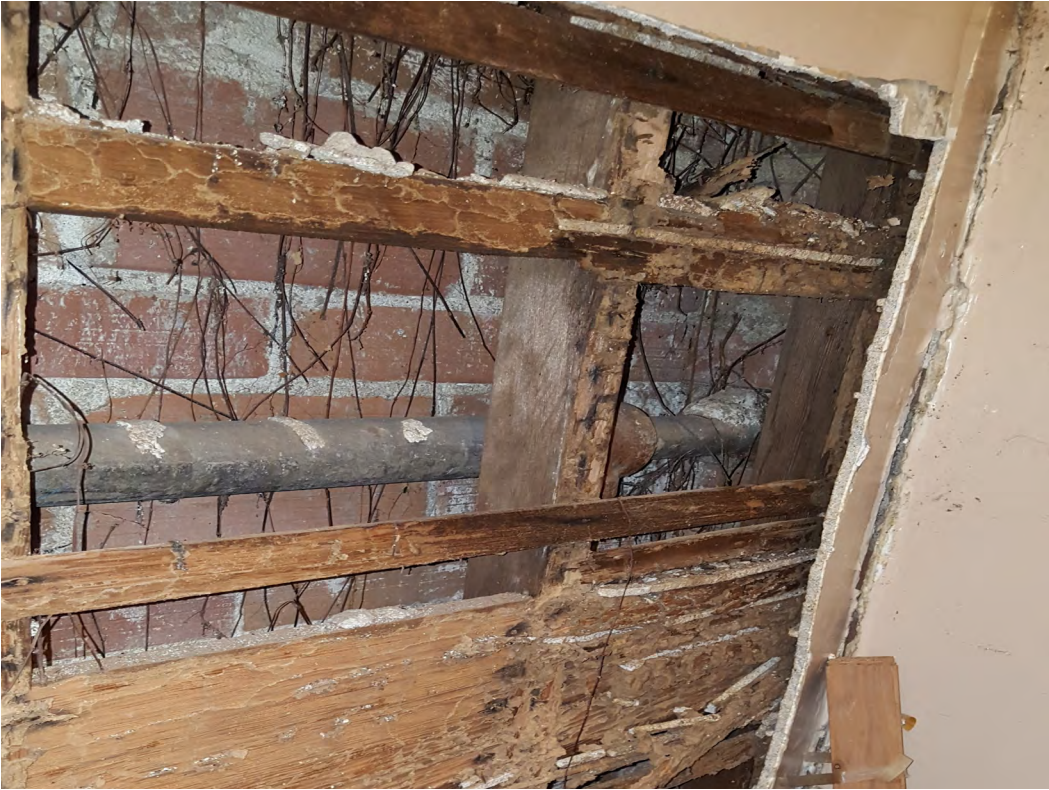
2

Wall structure and finish surface damage ad "D" wing. Dry-rot and water damage too.

Note vines growing between masonry wall and stud wall.

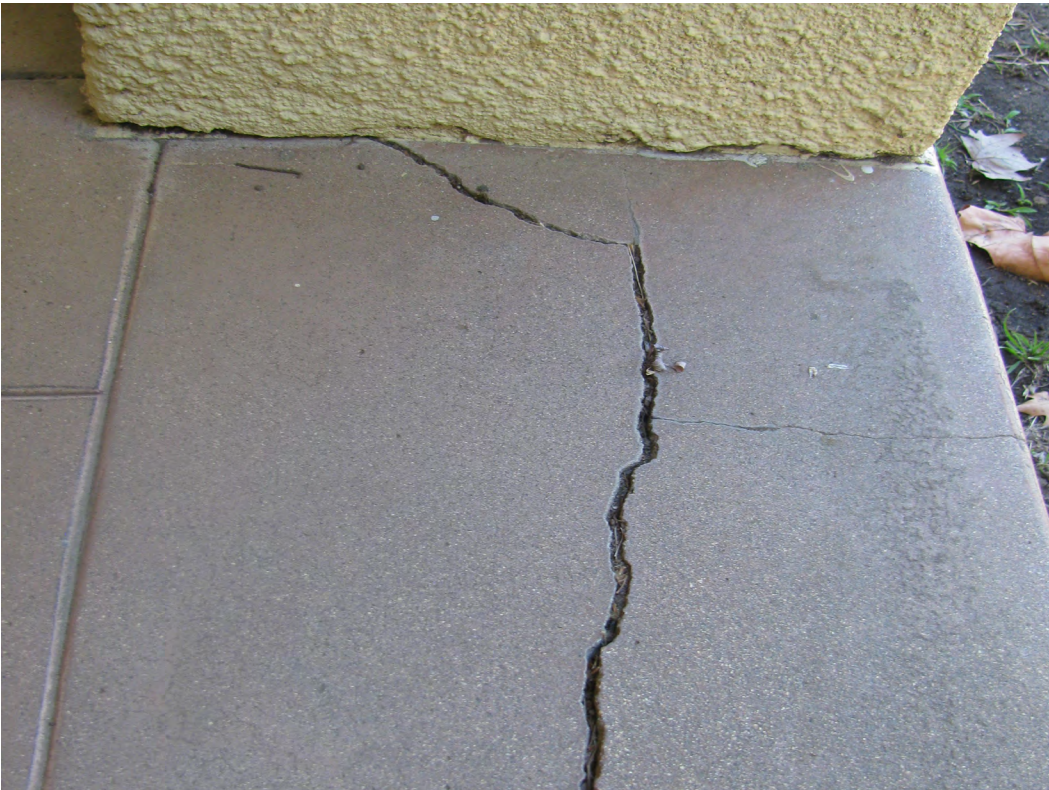
3

Structural cracks in the concrete at the entry colonnade paving.
